PHOTOGRAPHIC SURVEY OF THE LDEF MISSION

National Aeronautics and
Space Administration

NASA Special Publication 531
1996

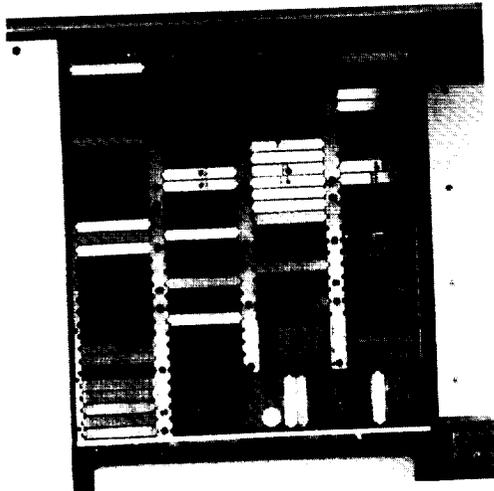
Figure 347
Photo No. KSC-390C-1534.12
Dup. Neg. No.: L91-10309
LISAR No.: EL-1994-00650
Photo Credit: KSC
Photo Date: 2/27/90
Location: KSC SAEF II
Subject: Postflight Detail of Lower Center of
Tray D8

Figure 347 (Postflight). This photograph is of the lower center one-sixth of the tray. Many of the test samples have changed color and have degraded finishes. The test specimen mounting hardware has numerous brown discolorations.

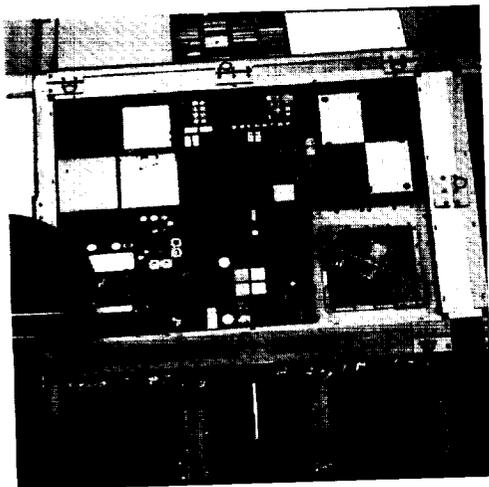
Figure 353
Photo No.: S32-78-093
Dup. Neg. No.: L90-10450
LISAR No.: EL-1994-00124
Photo Credit: JSC
Photo Date: 1/12/90
Location: In Flight
Subject: In-Flight Survey of Tray D9

Figure 353 (In Flight). The experiments located in the upper left and upper center sections are heavily coated with debris particles from other degraded experiments. Experiments in three of the five sections appear to have survived the mission with only minor physical damage. Experiments in the other two sections have sustained damage to thin metallized and coated polymer samples.

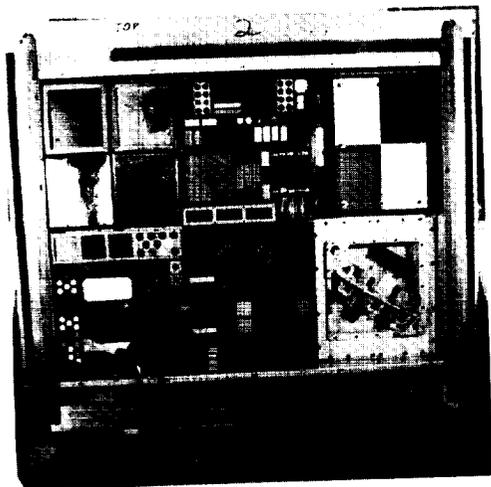
Figure 354
Photo No.: KSC-390C-1529.03
Dup. Neg. No.: L91-10336
LISAR No.: EL-1994-00211
Photo Credit: KSC
Photo Date: 2/27/90
Location: KSC SAEF II
Subject: Postflight Survey of Tray D9

Figure 354 (Postflight). Experiments in three of the five sections appear to have survived the mission with minor physical damage. The experiments located in the upper left and upper center sections do not have the loose debris particles from the degradation of other experiments that were visible in the in-flight photograph. Experiments in the other two sections have sustained damage to thin metallized and coated polymer samples.

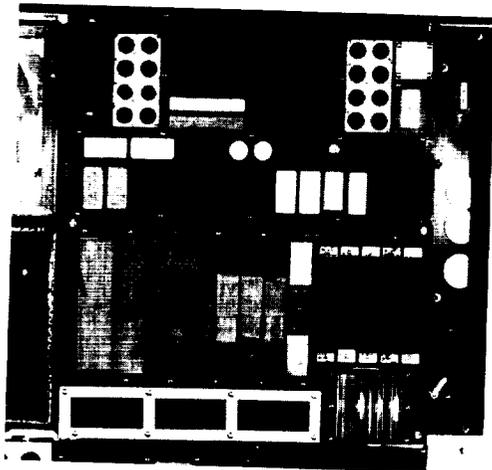
Figure 356
Photo No.: KSC-390C-1529.05
Dup. Neg. No.: L91-10338
LISAR No.: EL-1994-00324
Photo Credit: KSC
Photo Date: 2/27/90
Location: KSC SAEF II
Subject: Postflight Detail of Upper Center of
Tray D9

Figure 356 (Postflight). This photograph is of the upper center one-sixth of the tray. The test samples appear intact, but many are discolored.

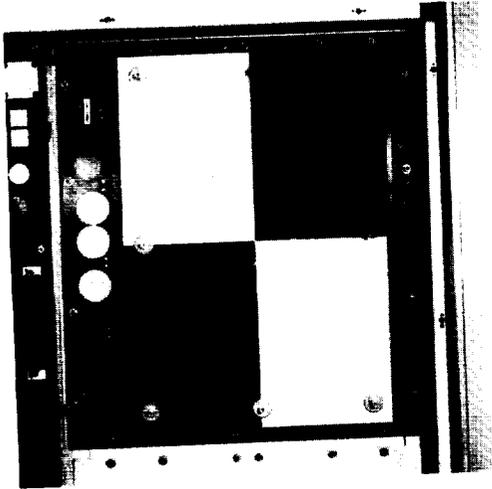
Figure 357
Photo No.: KSC-390C-1529.06
Dup. Neg. No.: L91-10339
LISAR No.: EL-1994-00096
Photo Credit: KSC
Photo Date: 2/27/90
Location: KSC SAEF II
Subject: Postflight Detail of Upper Right of Tray D9

Figure 357 (Postflight). This photograph is of the upper right one-sixth of the tray. The test samples appear intact, but there seems to be some discoloration near the upper left corner of the baseplate.

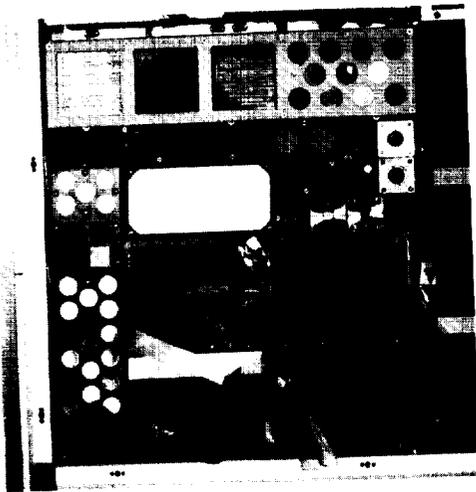
Figure 358
Photo No.: KSC-390C-1529.07
Dup. Neg. No.: L91-10340
LISAR No.: EL-1994-00097
Photo Credit: KSC
Photo Date: 2/27/90
Location: KSC SAEF II
Subject: Postflight Detail of Lower Left of Tray D9

Figure 358 (Postflight). This photograph is of the lower left one-sixth of the tray. Many of the thin-film test specimens have broken and are attached by one end. Other test specimens appear intact, but some are discolored.

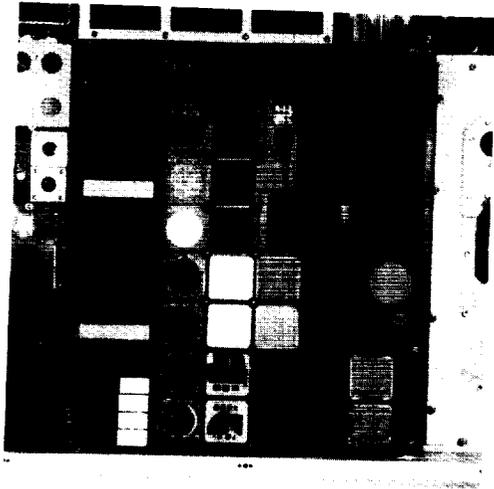
Figure 359
Photo No.: KSC-390C-1529.08
Dup. Neg. No.: L91-10341
LISAR No.: EL-1994-00649
Photo Credit: KSC
Photo Date: 2/27/90
Location: KSC SAEF II
Subject: Postflight Detail of Lower Center of
Tray D9

Figure 359 (Postflight). This photograph is of the lower center one-sixth of the tray. Loose ends of thin-film test samples are visible at the lower left corner. Other test specimens appear intact, but have some discoloration.

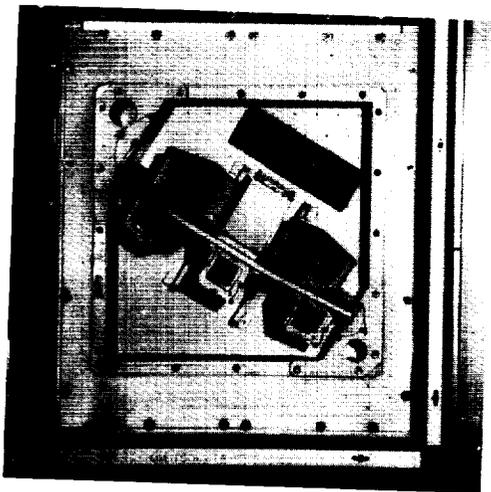
Figure 360
Photo No.: KSC-390C-1529.09
Dup. Neg. No.: L91-10342
LISAR No.: EL-1994-00649
Photo Credit: KSC
Photo Date: 2/27/90
Location: KSC SAEF II
Subject: Postflight Detail of Lower Right of
Tray D9

Figure 360 (Postflight). This photograph is of the lower right one-sixth of the tray. This experiment appears intact with some brown discoloration.

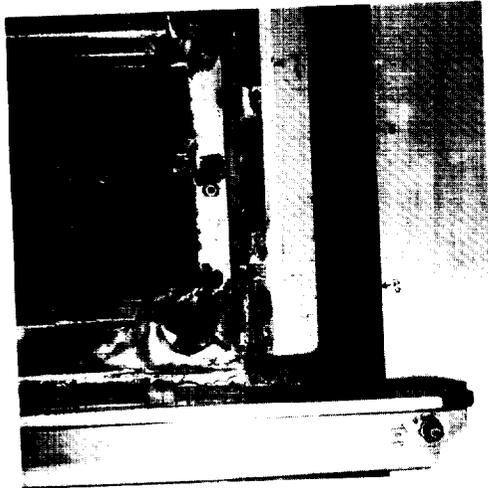
Figure 372
Photo No.: KSC-390C-1771.02
Dup. Neg. No.: L91-9116
LISAR No.: EL-1994-00394
Photo Credit: KSC
Photo Date: 3/9/90
Location: KSC SAEF II
Subject: Postflight Detail of Lower Right Corner of
Tray D10

Figure 372 (Postflight). This photograph is of the lower right corner of the tray. The VDA-Kapton strips used to cover spaces between the modules have degraded substantially and only fragments of the extremely fragile VDA layer remain.

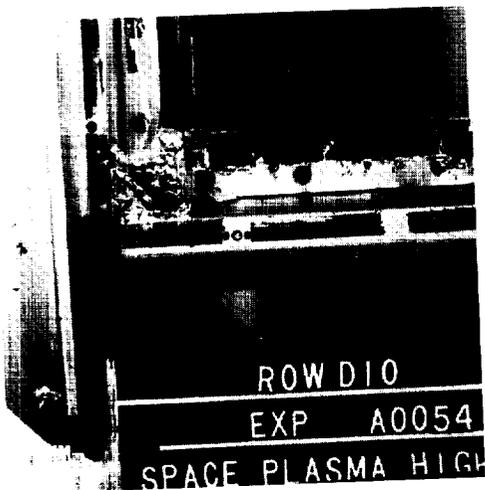
Figure 373
Photo No.: KSC-390C-1771.03
Dup. Neg. No.: L91-9117
LISAR No.: EL-1994-00395
Photo Credit: KSC
Photo Date: 3/9/90
Location: KSC SAEF II
Subject: Postflight Detail of Lower Left Corner of
Tray D10

Figure 373 (Postflight). This photograph is of the lower left corner of the tray. The VDA-Kapton strips used to cover spaces between the modules have degraded substantially and only fragments of the extremely fragile VDA layer remain.

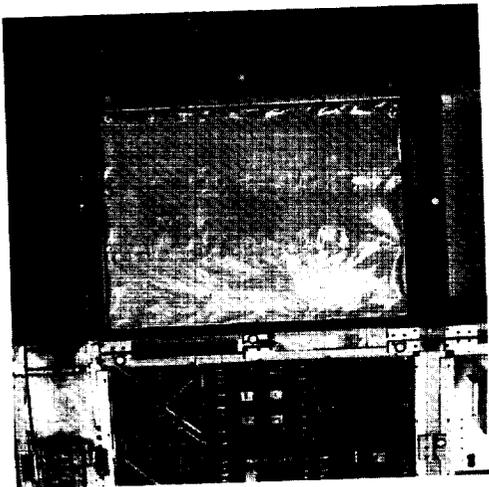
Figure 376 (In Flight). The thermal cover surface has changed from specular to opaque with numerous black dots and dimples of various sizes that indicate space debris impacts or penetrations. There is an area of reflected light in the lower right area. The cover is taut and the locations of Velcro attachment pads are prominent. The ground strap appears to have no visible damage, but it appears to be a deeper copper color.

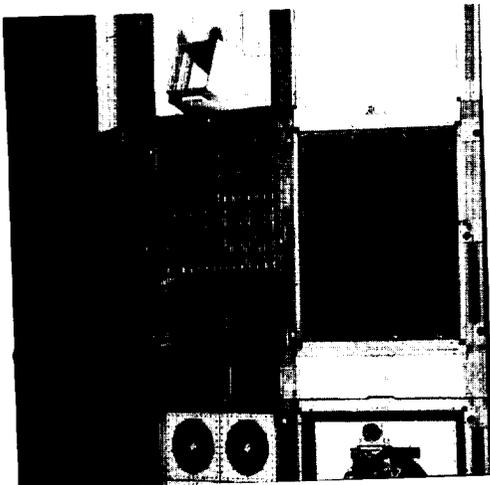
Figure 385
Photo No.: S32-89-052
Dup. Neg. No.: L90-10502
LISAR No.: EL-1994-00137
Photo Credit: JSC
Photo Date: 1/12/90
Location: In Flight
Subject: In-Flight Survey of Tray D12

Figure 385 (In Flight). All experiment test specimens and hardware appear intact. Reflected sunlight caused uneven lighting of the frames of experiment AO023 and a white shape on the tray sidewall above the experiment detector stack. There is some change in the colors of the material of experiment AO180. Note the change in color of the tray clamp white dots across the photograph. The change from white to brown indicates the transition between leading and trailing sides.

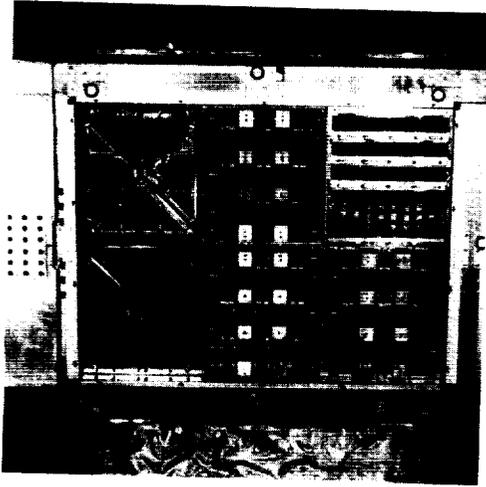
Figure 386
Photo No.: KSC-390C-1069.10
Dup. Neg. No.: L90-13490
LISAR No.: EL-1994-00203
Photo Credit: KSC
Photo Date: 2/8/90
Location: KSC SAEF II
Subject: Postflight Survey of Tray D5

Figure 386 (Postflight). All experiment hardware remains intact. No change from inflight appearance is apparent. There are light reflections on many sensor surfaces.

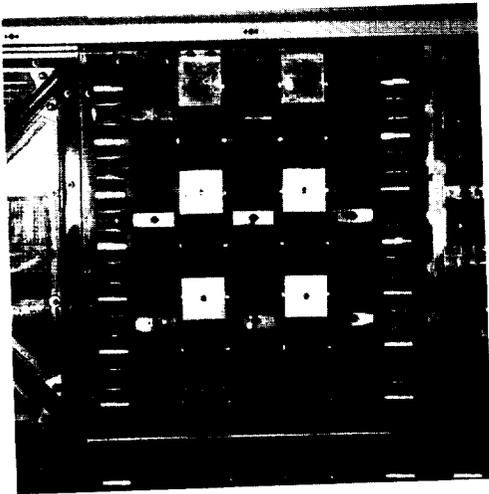
Figure 388
Photo No.: KSC-390C-2035.04
Dup. Neg. No.: L91-10380
LISAR No.: EL-1994-00457
Photo Credit: KSC
Photo Date: 3/16/90
Location: KSC SAEF II
Subject: Postflight Detail of Upper Center of
Tray D12

Figure 388 (Postflight). This photograph is of the upper center one-sixth of the tray. There is little change in the colors of the test specimens.

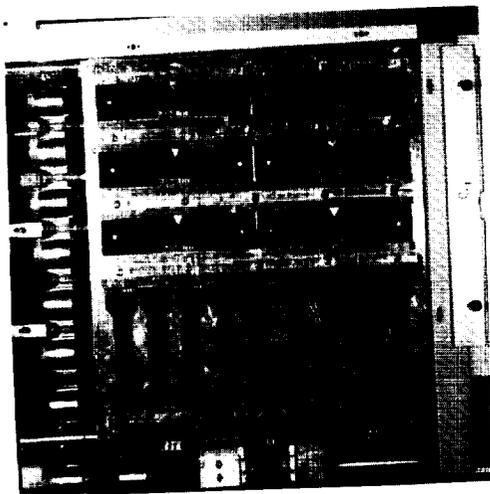
Figure 389
Photo No.: KSC-390C-2035.05
Dup. Neg. No.: L91-10381
LISAR No.: EL-1994-00458
Photo Credit: KSC
Photo Date: 3/16/90
Location: KSC SAEF II
Subject: Postflight Detail of Upper Right of
Tray D12

Figure 389 (Postflight). This photograph is of the upper right one-sixth of the tray. The test specimens are intact with no visible difference from preflight. The red passive temperature indicators remain bonded to the test specimens.

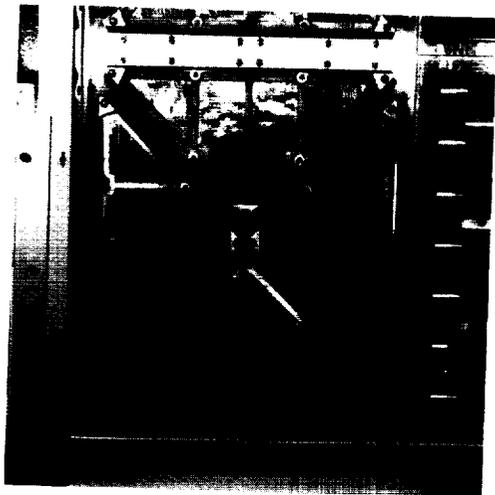
Figure 390
Photo No.: KSC-390C-2035.06
Dup. Neg. No.: L91-10382
LISAR No.: EL-1994-00459
Photo Credit: KSC
Photo Date: 3/16/90
Location: KSC SAEF II
Subject: Postflight Detail of Lower Left of Tray D12

Figure 390 (Postflight). This photograph is of the lower left one-sixth of the tray. The sensor foils in the triangular quadrants are intact and some light reflects on the foils of the upper section. There is some discolorations along the foil and mounting frame line of the left and right quadrants.

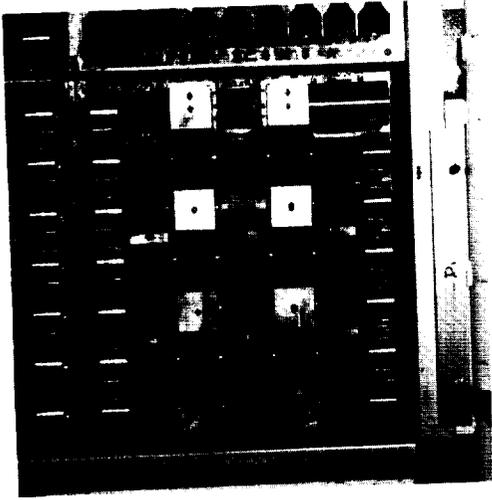
Figure 392
Photo No.: KSC-390C-2035.08
Dup. Neg. No.: L91-10384
LISAR No.: EL-1994-00461
Photo Credit: KSC
Photo Date: 3/16/90
Location: KSC SAEF II
Subject: Postflight Detail of Lower Right of
Tray D12

Figure 392 (Postflight). This photograph is of the lower right one-sixth of the tray. The test specimens are intact, but some are darker than in the preflight photograph.

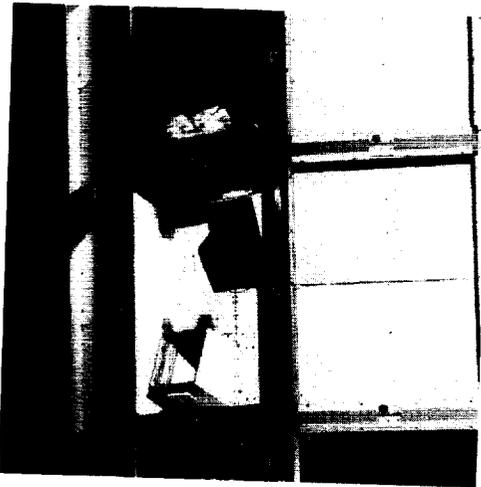
Figure 393 (In Flight). The pink and greenish-gray tints on the two debris panels are by-products of the chromic anodize coating process and are not attributed to contamination or exposure to the space environment. The light color band across the top of the panels is a reflection from the tray sidewall.

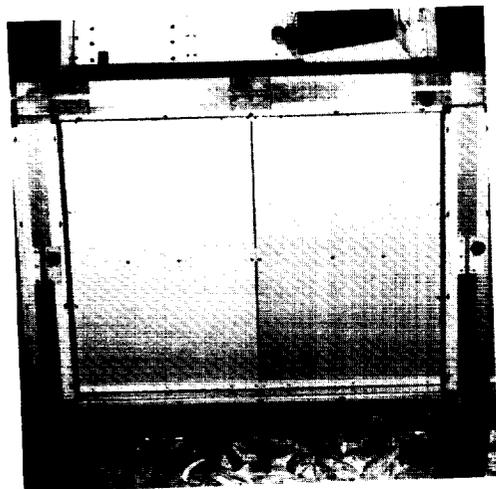
Figure 394
Photo No.: KSC-390C-1066.08
Dup. Neg. No.: L90-13477
LISAR No.: EL-1994-00187
Photo Credit: KSC
Photo Date: 2/8/90
Location: KSC SAEF II
Subject: Postflight Survey of Tray E1

Figure 394 (Postflight). The pink and greenish-gray tints on the two debris panels are by-products of the chromic anodize coating process and are not attributed to contamination or exposure to the space environment. The light band along the bottom of the panels is caused by light reflecting from the tray sidewalls.

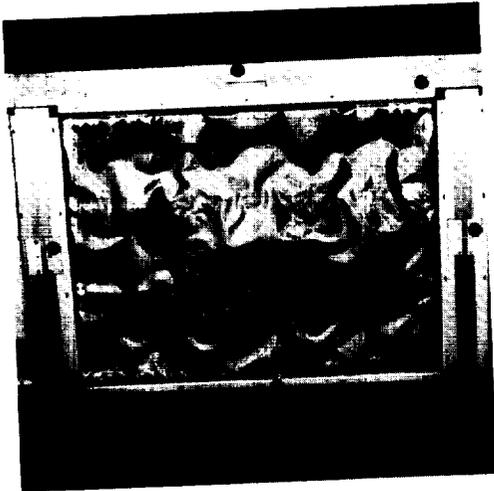
Figure 396
Photo No.: KSC-390C-1065.11
Dup. Neg.: L90-13468
LISAR No.: EL-1994-00385
Photo Credit: KSC
Photo Date: 2/8/90
Location: KSC SAEF II
Subject: Postflight Survey of Tray E2

Figure 396 (Postflight). The thermal cover appears to be specular with no apparent damage. It is less taut than in the in-flight photograph. The Velcro attachment pads are more visible than in the prelaunch photograph. The scallop effect around the cover edges occurs between the attachment pads and shows the upper edge of the support frame. The ground strap is in place with no visible damage, but it is a darker color.

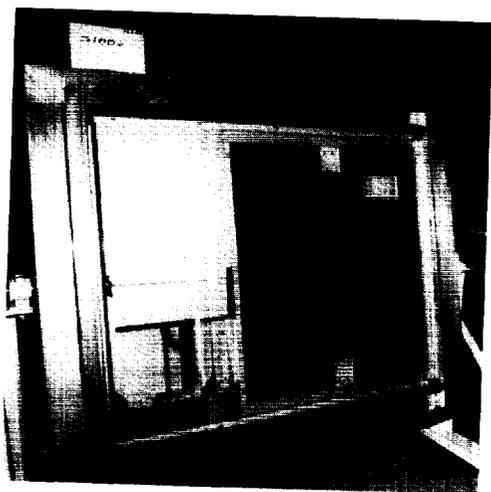
Figure 403
Photo No.: KSC-383C-4209.06
Dup. Neg. No.: L84-7293
LISAR No.: EL-1994-00301
Photo Credit: KSC
Photo Date: 12/1/83
Location: KSC SAEF II
Subject: Preflight Survey of Tray E3

Figure 403 (Preflight). This photograph shows experiment AO187-2 in the right two-thirds of the tray and the EECC that contained experiment S1002 in the left one-third. The tan strips on the tray flanges are protective coatings that were removed prior to tray testing. Each of the 77 capture cells of experiment AO187-2 consisted of four highly polished germanium plates. These plates were covered with a 2.5- μm thick Mylar foil with 1300 A of tantalum vapor that was deposited on the back and 100 A of gold-palladium that was vapor deposited on the front. Two calorimeters are shown mounted in the top center and lower center of the experiment panel. An aluminum cover in the upper right section of the panel protected electrical connections. Reflections of both personnel and equipment are visible in the metallic-coated Mylar foil that covers the germanium detector plates.

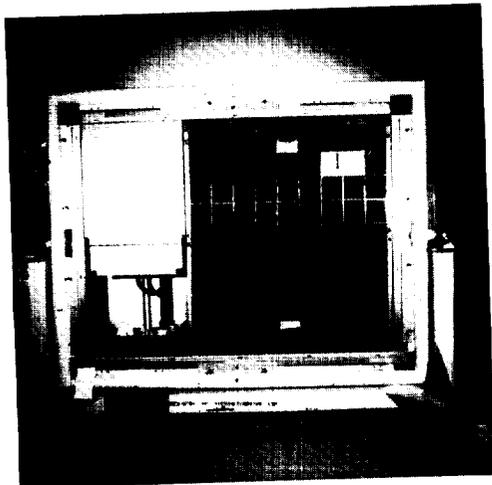
Figure 405
Photo No.: KSC-390C-1839.02
Dup. Neg. No.: L91-10443
LISAR No.: EL-1994-00278
Photo Credit: KSC
Photo Date: 3/12/90
Location: KSC SAEF II
Subject: Postflight Survey of Tray E3

Figure 405 (Postflight). The capture cells have degraded and only 11 of the 77 metallized Mylar covers survived. There is a brown stain on the tray, the capture cell mounting, and the calorimeter mounting plates. The green tint on the right side of the experiment is a reflection of lights from an adjacent room. The canister for experiment S1002 is closed.

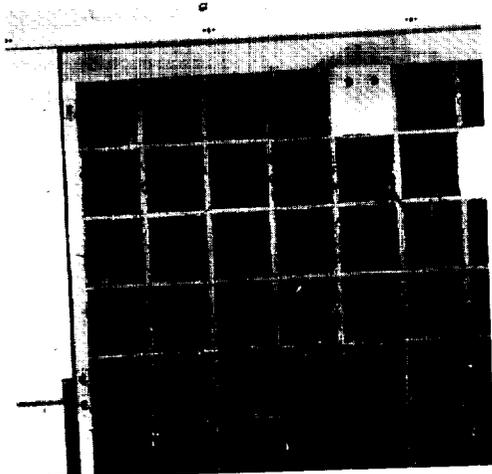
Figure 406
Photo No.: KSC-390C-1839.04
Dup. Neg. No.: L91-10445
LISAR No.: EL-1994-00404
Photo Credit: KSC
Photo Date: 3/12/90
Location: KSC SAEF II
Subject: Postflight Detail of Upper Left of Tray E3

Figure 406 (Postflight). This photograph is of the upper left one-fourth of experiment AO187-2. Two capture cell covers are intact. The remains of the others are curled tightly and hanging from one edge. There is considerable discoloration on the upper mounting frame and on the calorimeter.

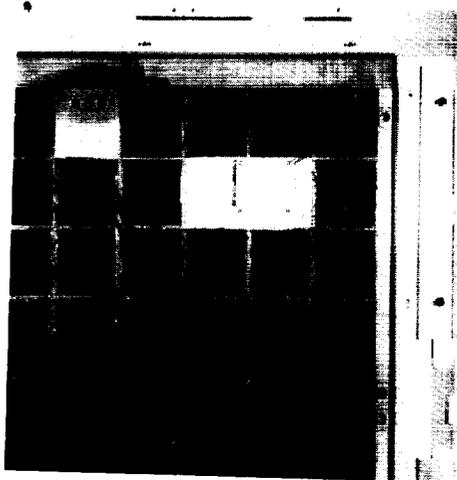
Figure 407
Photo No.: KSC-390C-1839.05
Dup. Neg. No.: L91-10446
LISAR No.: EL-1994-00405
Photo Credit: KSC
Photo Date: 3/12/90
Location: KSC SAEF II
Subject: Postflight Detail of Upper Right of Tray E3

Figure 407 (Postflight). This photograph is of the upper right one-fourth of experiment AO187-2. Three capture cell covers are intact. The remains of the others are curled tightly and are hanging from one edge. There is considerable discoloration on the upper and right sides of the mounting frame and on the calorimeter.

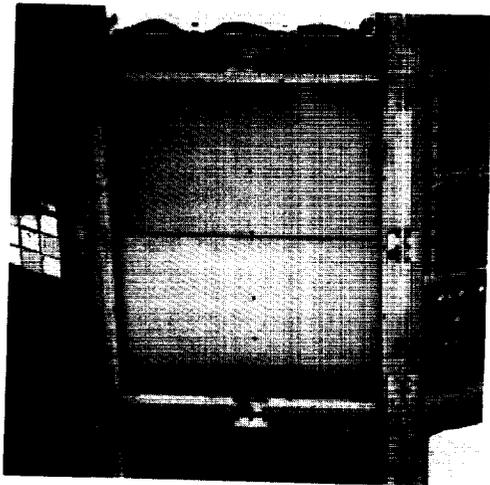
Figure 410
Photo No.: S32-77-048
Dup. Neg. No.: L90-10412
LISAR No.: EL-1994-00678
Photo Credit: JSC
Photo Date: 1/12/90
Location: KSC SAEF II
Subject: In-Flight Survey of Tray E4

Figure 410 (In Flight). The greenish-gray and pink tints on the two debris panels are by-products of the chromic anodize coating process and are not attributed to contamination or exposure to the space environment. Discolorations are visible along some edges of the panels, thus indicating improper handling and cleaning after panel assembly.

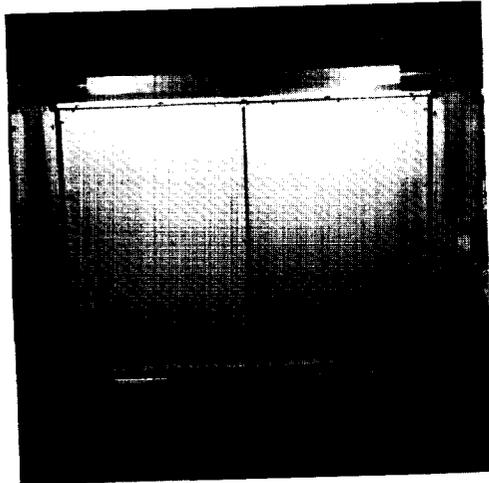
Figure 411
Photo No.: KSC-390C-832.03
Dup. Neg. No.: L90-13350
LISAR No.: EL-1994-00172
Photo Credit: KSC
Photo Date: 2/7/90
Location: KSC SAEF II
Subject: Postflight Survey of Tray E4

Figure 411 (Postflight). The greenish-gray and pink tints on the two debris panels are by-products of the chromic anodize coating process and are not attributed to contamination or exposure to the space environment. The fingerprints along the bottom edge of the panels that were observed in the in-flight photograph are still visible. The light band along the sides and across the bottom of the tray is caused by light reflected from the tray sidewalls.

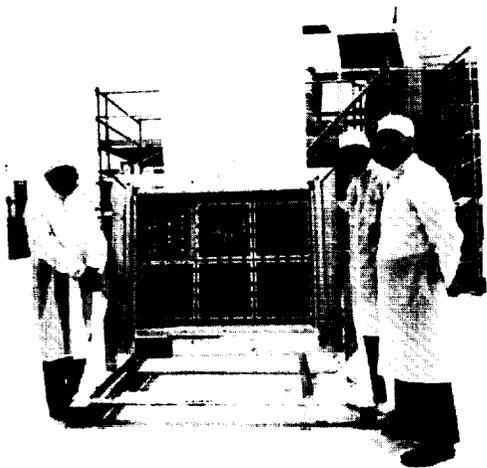
Figure 412
Photo No.: KSC-384C-255.06
Dup. Neg. No.: L89-4387
LISAR No.: EL-1994-00372
Photo Credit: KSC
Photo Date: 1/18/90
Location: KSC SAEF II
Subject: Preflight Survey of Tray E5

Figure 412 (Preflight). The test specimens were typically placed on fiberglass-epoxy retainer strip assemblies and mounted in the tray. Five of the six sections of the tray were covered by a 1/8-in-thick anodized aluminum sun screen with openings that allowed 56-percent transmission over the central region. The remaining one-sixth was open to the space environment.

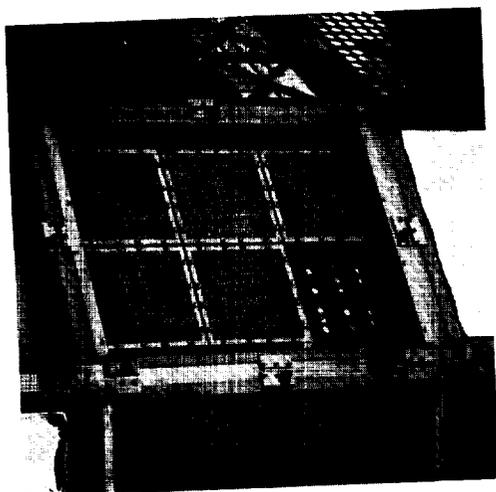
Figure 413
Photo No.: S32-77-050
Dup. Neg. No.: L90-10413
LISAR No.: EL-1994-00679
Photo Credit: JSC
Photo Date: 1/12/90
Location: KSC SAEF II
Subject: In-Flight Survey of Tray E5

Figure 413 (In Flight). In this photograph, the experiment hardware appears to be without physical damage. The blue is due to lighting. The exposed experiment test specimens and the fiberglass-epoxy mountings appear to have survived the mission. The colors of the fiberglass-epoxy mounting strip have changed from the typical greenish gray to a slate gray and the colors of the test specimen appear to be much darker than in the prelaunch photograph.

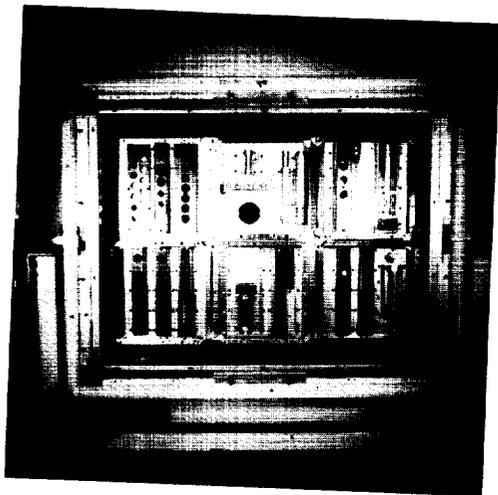
Figure 415
Photo No.: KSC-390C-2114.03
Dup. Neg. No.: L91-10508
LISAR No.: EL-1994-00491
Photo Credit: KSC
Photo Date: 3/20/90
Location: KSC SAEF II
Subject: Postflight Survey of Tray E5

Figure 415 (Postflight). This photograph was taken after the experiment tray was removed from the LDEF and the sun screens were removed. The experiment hardware appears to be without physical damage. The colors of the fiberglass-epoxy mounting strip vary from the typical greenish gray to a slate gray in proportion to their exposure. The red material on top of the aluminum support structure are silicon rubber gaskets between the sun screen and the structure. The gasket material that is missing adhered to the sun screens.

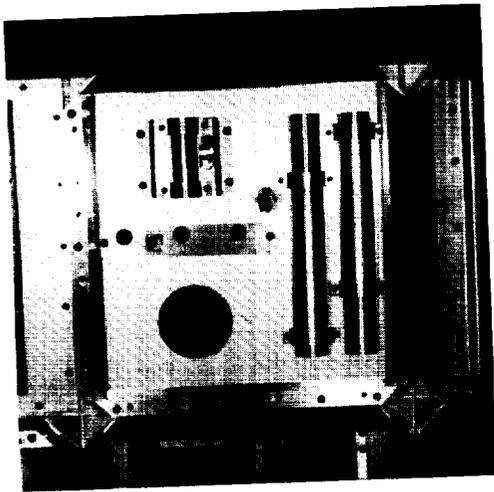
Figure 416
Photo No.: KSC-390C-2114.04
Dup. Neg. No.: L91-10509
LISAR No.: EL-1994-00492
Photo Credit: KSC
Photo Date: 3/20/90
Location: KSC SAEF II
Subject: Postflight Detail of Upper Center of
Tray E5

Figure 416 (Postflight). This photograph is of the upper center one-sixth of the tray. The experiment hardware is without physical damage.

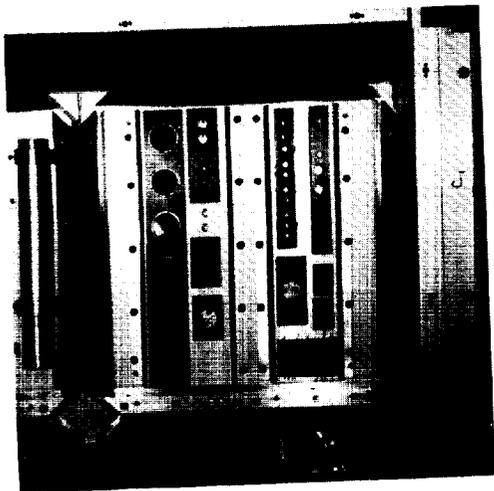
Figure 417
Photo No.: KSC-390C-2114.05
Dup. Neg. No.: L91-10510
LISAR No.: EL-1994-00493
Photo Credit: KSC
Photo Date: 3/20/90
Location: KSC SAEF II
Subject: Postflight Detail of Upper Right of Tray E5

Figure 417 (Postflight). This photograph is of the upper right one-sixth of the tray. The experiment hardware is without physical damage.

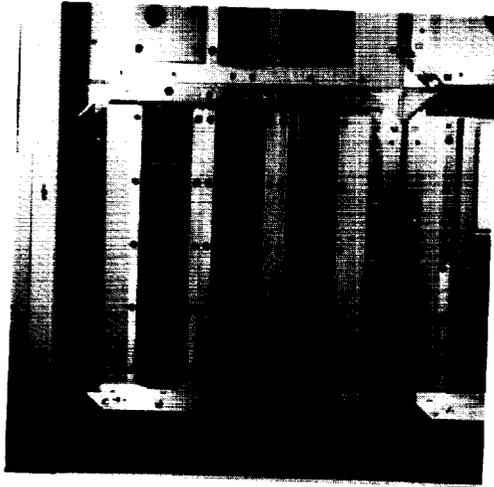
Figure 418
Photo No.: KSC-390C-2114.06
Dup. Neg. No.: L91-10511
LISAR No.: EL-1994-00494
Photo Credit: KSC
Photo Date: 3/20/90
Location: KSC SAEF II
Subject: Postflight Detail of Lower Left of Tray E5

Figure 418 (Postflight). This photograph is of the lower left one-sixth of the tray. The experiment hardware is without physical damage.

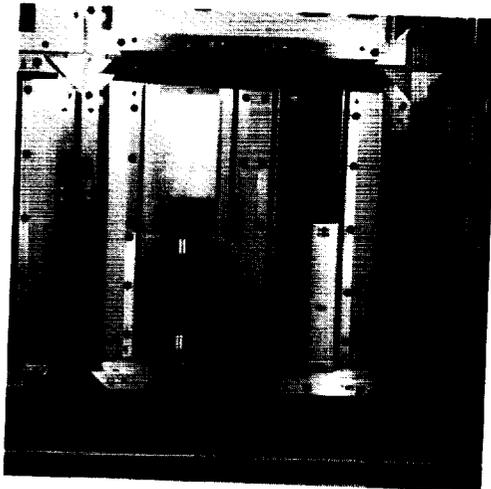
Figure 419
Photo No.: KSC-390C-2114.07
Dup. Neg. No.: L91-10512
LISAR No.: EL-1994-00495
Photo Credit: KSC
Photo Date: 3/20/90
Location: KSC SAEF II
Subject: Postflight Detail of Lower Center of
Tray E5

Figure 419 (Postflight). This photograph is of the lower center one-sixth of the tray. The experiment hardware is without physical damage.

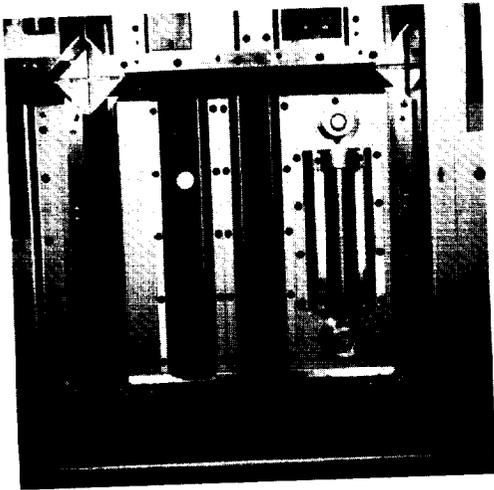
Figure 420 (Postflight). This photograph is of the lower right one-sixth of the tray. The experiment hardware is without physical damage.

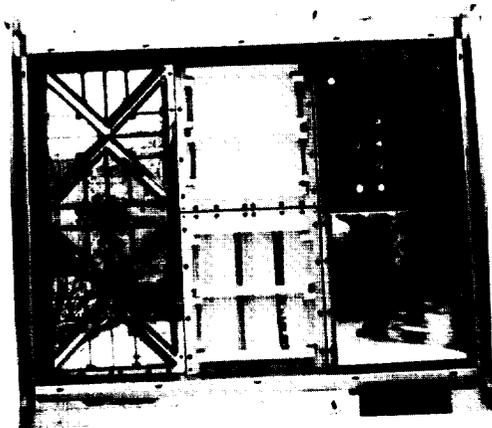
Figure 421
Photo No.: KSC-384C-193.10
Dup. Neg. No.: L84-7068
LISAR No.: EL-1994-00356
Photo Credit: KSC
Photo Date: 1/12/84
Location: KSC SAEF II
Subject: Preflight Survey of Tray E6

Figure 421 (Preflight). In this photograph, experiment AO023, described in figure 230, is shown in the left one-third section. Experiment S1006 occupies the center one-third section. Experiment M0002-2 is in the lower right section. Experiment S1003 is in the top right section of the 3-in-deep tray. Discolorations are visible on the die-cast frames of experiment AO023. Light reflections cause areas of the thin sensor films of experiment AO023 to appear dark.

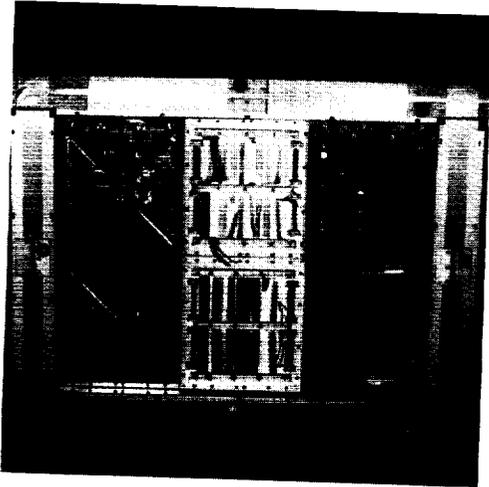
Figure 423
Photo No.: KSC-390C-1033.09
Dup. Neg. No.: L90-13439
LISAR No.: EL-1994-00179
Photo Credit: KSC
Photo Date: 2/9/90
Location: KSC SAEF II
Subject: Postflight Survey of Tray E6

Figure 423 (Postflight). Experiment AO023 has no visible physical damage, but the die-cast frames have discolorations. The detector assemblies of experiment M0002-2 appear to be without physical damage. The source of the discolorations on the aluminized Kapton cover, which appear as horizontal scratches and vertical bands, is unknown. The hardware of experiment S1003 appears to be intact and experiment samples appear to have only minor changes. Many of the material samples in experiment S1006 seem to have severely degraded and the base plate is discolored.

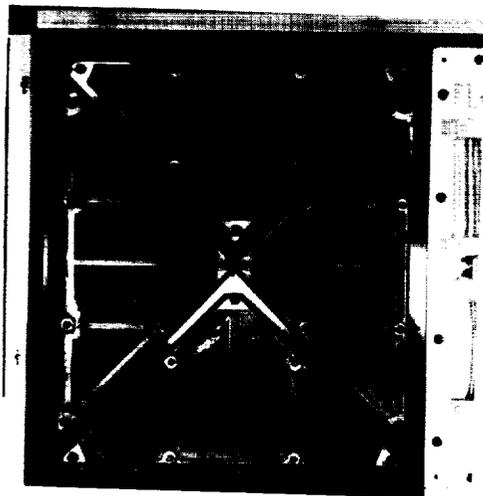
Figure 424
Photo No.: KSC-390C-1992.04
Dup. Neg. No.: L91-10538
LISAR No.: EL-1994-00413
Photo Credit: KSC
Photo Date: 3/15/90
Location: KSC SAEF II
Subject: Postflight Detail of Upper Left of Tray E6

Figure 424 (Postflight). This photograph is of the upper left one-sixth of the tray. The hardware of experiment AO023 is intact. Light reflections are evident in the sensor foil surfaces. There is discoloration on the upper triangular die-cast mounting frame.

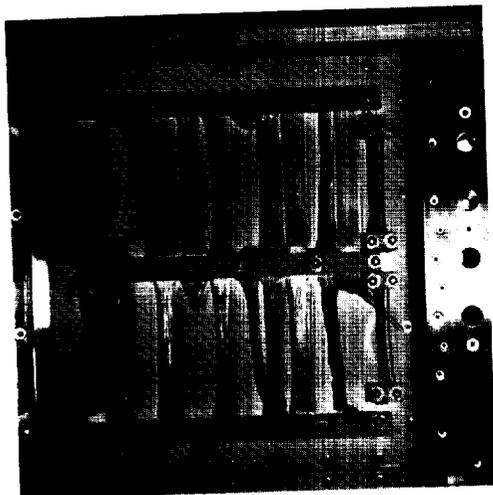
Figure 425
Photo No.: KSC-390C-1992.05
Dup. Neg. No.: L91-10539
LISAR No.: EL-1994-00414
Photo Credit: KSC
Photo Date: 3/15/90
Location: KSC SAEF II
Subject: Postflight Detail of Upper Center of
Tray E6

Figure 425 (Postflight). This photograph is of the upper center one-sixth of the tray. The thin-film polymeric material samples in experiment S1006 have been severely degraded. All 26 of the unreinforced thin-film samples have curled edges. Twelve samples appear to have failed in tension and a significant portion of the two aluminized polymer samples appears to be missing. The IITRI S13G-LO white paint on the baseplate has a light tan discoloration.

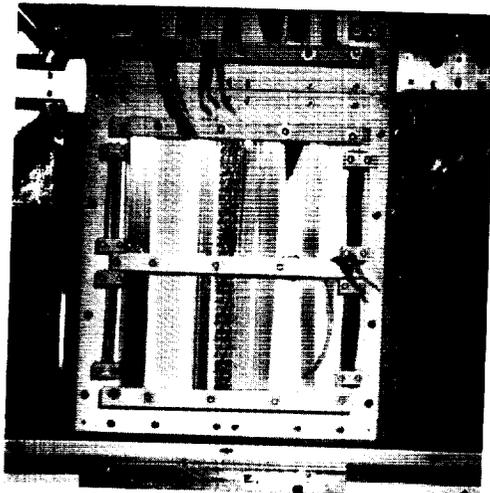
Figure 428
Photo No.: KSC-390C-1992.08
Dup. Neg. No.: L91-10542
LISAR No.: EL-1994-00417
Photo Credit: KSC
Photo Date: 3/15/90
Location: KSC SAEF II
Subject: Postflight Detail of Lower Center of
Tray E6

Figure 428 (Postflight). This photograph is of the lower center one-sixth of the tray. The test specimens of experiment S1006 have suffered some degradation. The reinforced thin-film polymer samples are discolored, but they have survived the mission intact. The IITRI S13G-LO white paint on the baseplate has a light tan discoloration in areas that were not covered by experiment samples (with evidence that at least some of the discoloration occurred after sample failure).

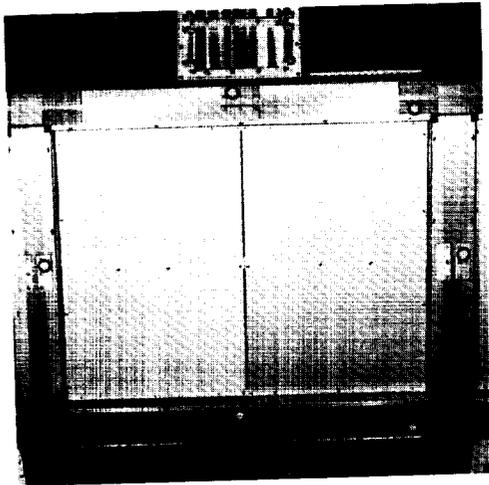
Figure 431
Photo No.: KSC-390C-1032.03
Dup. Neg. No.: L90-13425
LISAR No.: EL-1994-00148
Photo Credit: KSC
Photo Date: 2/9/90
Location: KSC SAEF II
Subject: Postflight Survey of Tray E7

Figure 431 (Postflight). The pink and greenish-gray tints on the two debris panels are by-products of the chromic anodize coating process and are not attributed to contamination or exposure to the space environment. The streaks on the debris panels that were noted in the in-flight photographs are almost invisible because the reflection of the sky is not present. The light band along the sides and across the bottom of the panels is caused by light reflecting from the tray sidewalls.

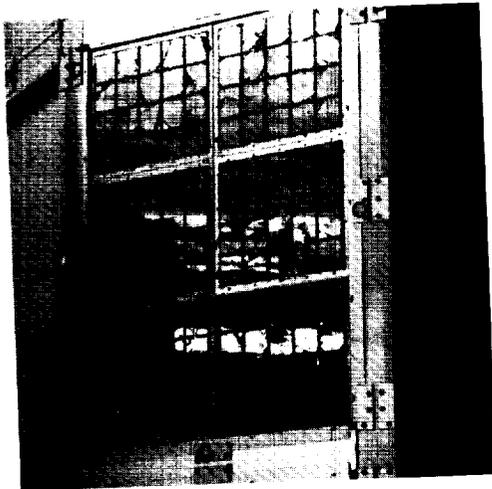
Figure 433
Photo No.: S32-76-016
Dup. Neg. No.: L90-10378
LISAR No.: EL-1994-00663
Photo Credit: JSC
Photo Date: 1/12/90
Location: In Flight
Subject: In-Flight Survey of Tray E8

Figure 433 (In Flight). The RMS arm of the Shuttle is reflected in the surface of the exposed germanium detector plates. The experiment has severely degraded. The metallic-coated Mylar film covers have failed on each of the capture cells and curled tightly into conical shapes.

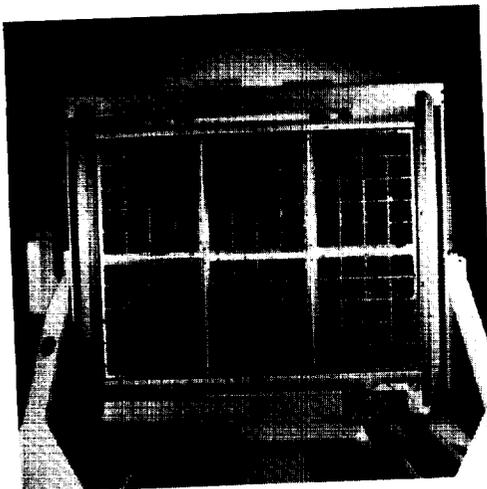
Figure 434
Photo No.: KSC-390C-1767.02
Dup. Neg. No.: L91-10614
LISAR No.: EL-1994-00267
Photo Credit: KSC
Photo Date: 3/90/90
Location: KSC SAEF II
Subject: Postflight Survey of Tray E8

Figure 434 (Postflight). The metallic-coated thin Mylar film has been lost on each of the capture cells. As the thin Mylar film failed, the material curled tightly into small conical shapes and is still attached to the edges of the aluminum mounting structure. The green tint on the germanium plate at the right edge of the experiment tray is a reflection from the lights in the high bay area of SAEF II. Dim reflections are visible on other sections of the experiment.

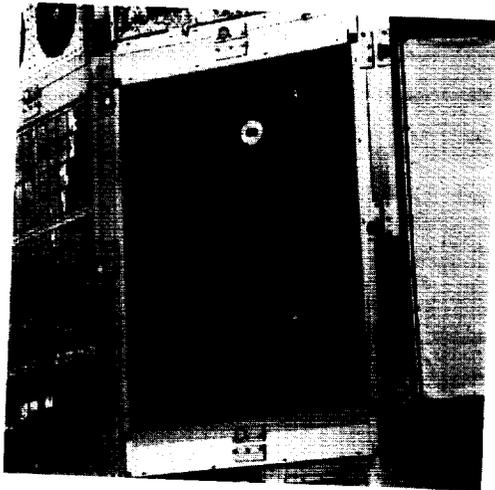
Figure 442
Photo No.: S32-78-090
Dup. Neg. No.: L90-10449
LISAR No.: EL-1994-00021
Photo Credit: JSC
Photo Date: 1/12/90
Location: In Flight
Subject: In-Flight Survey of Tray E9

Figure 442 (In Flight). The Chemglaze Z-306 black paint on the exposed surfaces has degraded, thus leaving the Chemglaze 9924 primer, which is reddish brown, clearly visible. The difference in the amount of paint remaining may be a function of initial paint thickness; the plate covering the center section was not painted at the same time as the other two plates. The experiment appears intact with little, if any damage.

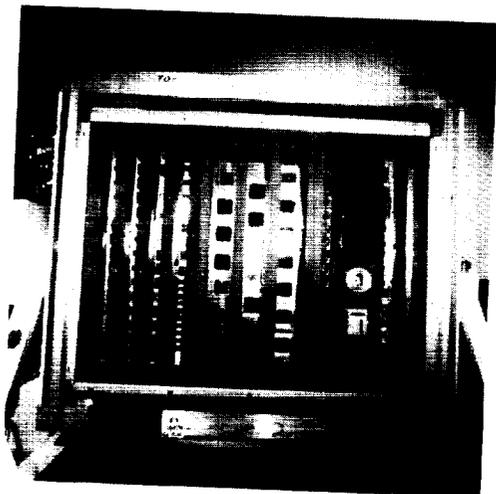
Figure 443
Photo No.: KSC-390C-1840.10
Dup. Neg. No.: L91-10676
LISAR No.: EL-1994-00279
Photo Credit: KSC
Photo Date: 3/12/90
Location: KSC SAEF II
Subject: Postflight Survey of Tray E9

Figure 443 (Postflight). The degradation of the Chemglaze Z-306 black paint on the exposed surfaces is evident by the amount of Chemglaze 9924 primer, which is reddish brown, that is visible. The difference in the amount of paint remaining may be a function of initial paint thickness; the plate covering the center section of the tray was not painted at the same time as the other two plates. The small gold-colored rectangular plate in the lower right section of the tray was fabricated from an aluminum alloy and coated with a clear anodize. A light brown discoloration is visible on the solar cell mounting plates and on areas of the aluminum base structure.

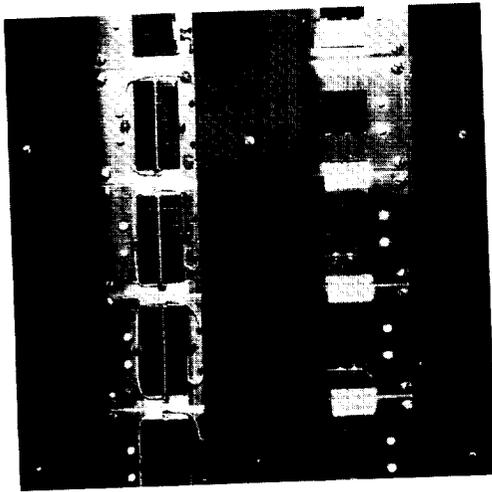
Figure 444
Photo No.: KSC-390C-1842.03
Dup. Neg. No.: L91-10681
LISAR No.: EL-1994-00408
Photo Credit: KSC
Photo Date: 3/12/90
Location: KSC SAEF II
Subject: Postflight Detail of Left Two Rows of
Tray E9

Figure 444 (Postflight). This close-up photograph is of the two left rows. No physical damage is evident.

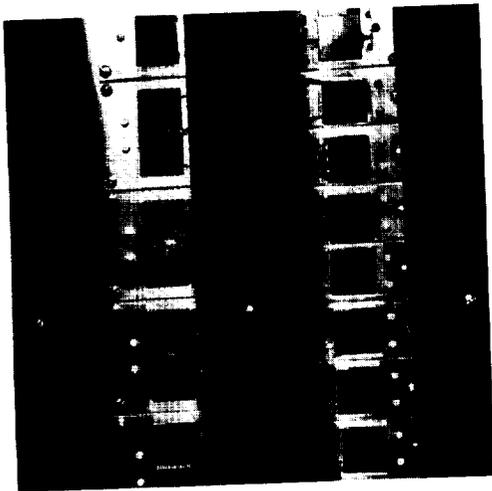
Figure 445
Photo No.: KSC-390C-1842.07
Dup. Neg. No.: L91-10685
LISAR No.: EL-1994-00418
Photo Credit: KSC
Photo Date: 3/12/90
Location: KSC SAEF II
Subject: Postflight Detail of Third and Fourth Rows
of Tray E9

Figure 445 (Postflight). This close-up photograph is of the third and the fourth rows. No physical damage is evident.

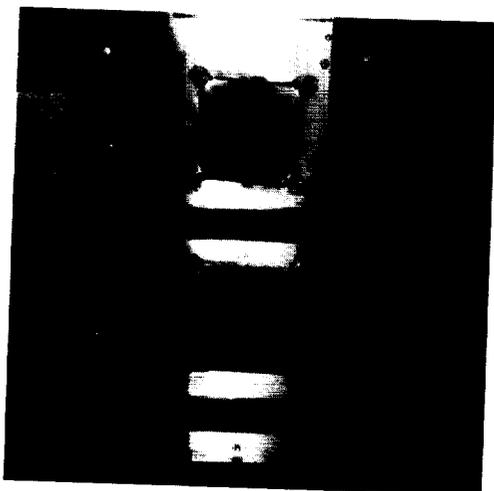
Figure 447 (Postflight). This close-up photograph is of the sixth row. There appears to be no physical damage, but some brown discoloration around the edges of the solar cells is evident.

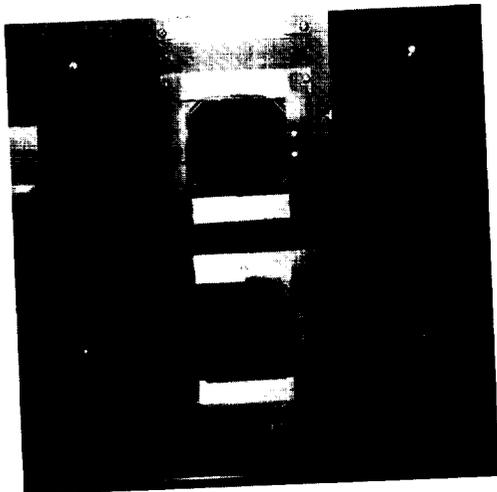
Figure 448 (Postflight). This close-up photograph is of the seventh row. There appears to be no physical damage, but some brown discoloration around the edges of the solar cells is evident.

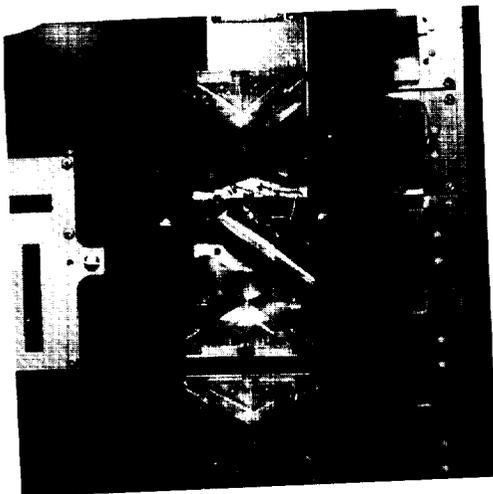
Figure 449 (Postflight). This close-up is of the ninth row. A solar concentrator cell, located at the lower end of the slot, appears to be damaged. The large piece of gold-colored material lodged in the slot appears to be a segment of the aluminum deposited on the Kapton mirror.

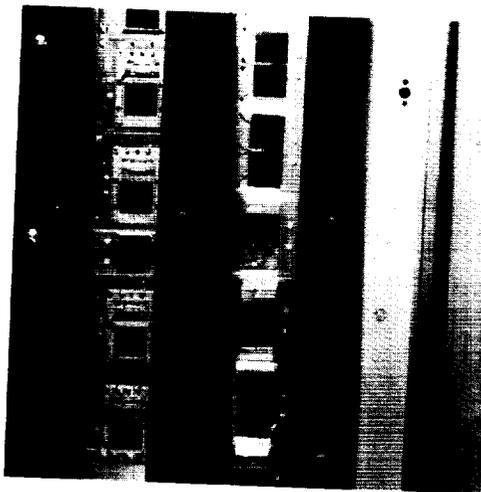
Figure 450 (Postflight). This close-up photograph is of the tenth row. There appears to be no physical damage, but the cell mounting frames have a mottled brown discoloration.

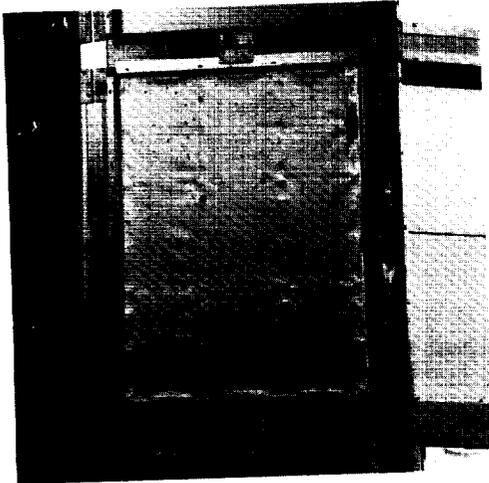
Figure 451 (In Flight). The surface of the thermal cover appears to have changed from specular to opaque with numerous black dots of various sizes, thus indicating impacts or penetrations. The cover is taut and the locations of Velcro attachment pads are prominent. The ground strap has no visible damage, but is a deeper copper color.

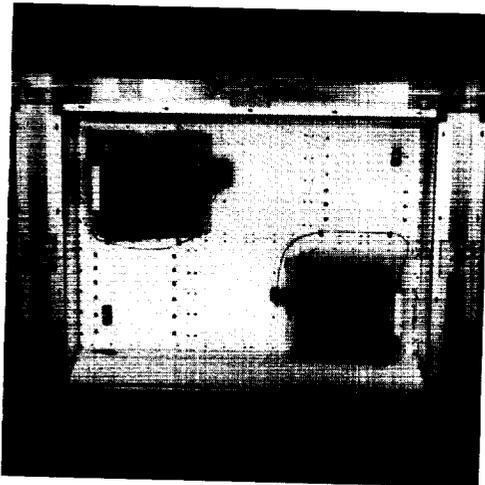
Figure 465 (Postflight). Brown stains are prominent, especially around the openings in the baseplate for the grid voltage cable connectors. The beryllium copper collector foils are clearly visible in this photograph, as are the baffles near the top of the canister housing. However, the fine wire mesh grid is not visible. Because of an experiment system malfunction, the canister collector foils that are visible were exposed for the total mission.

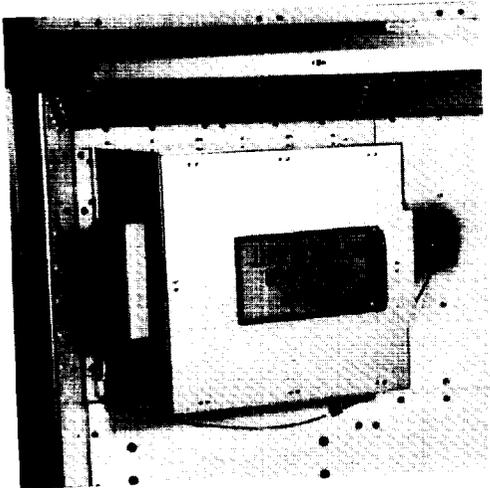
Figure 466 (Postflight). This photograph is of the upper left one-sixth of the tray. Note the brown discoloration in the tray corner and around the grid voltage plug to the right of the canister. The cover was installed on the canister housing to protect the space-exposed hardware.

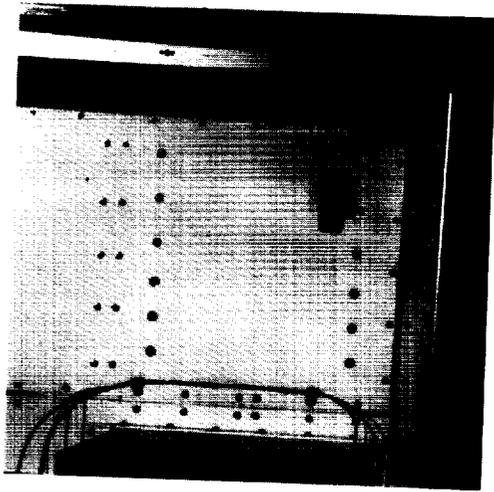
Figure 468 (Postflight). This photograph is of the upper right one-sixth of the tray. Note the light brown discoloration in the tray corner.

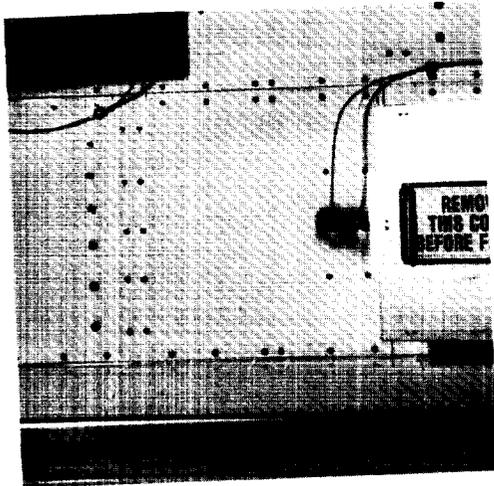
Figure 470 (Postflight). This photograph is of the lower center one-sixth of the tray. Note the brown discoloration around the grid voltage plug to the left of the canister. The cover was installed on the canister housing to protect the space-exposed hardware.

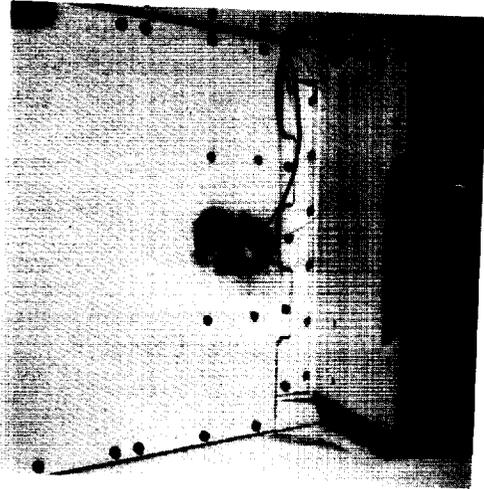
Figure 472
Photo No.: KSC-390C-1601.08
Dup. Neg. No.: L91-10775
LISAR No.: EL-1994-00098
Photo Credit: KSC
Photo Date: 3/5/90
Location: KSC SAEF II
Subject: Postflight Detail of Lower Right Corner
Canister of Tray E12

Figure 472 (Postflight). This close-up photograph is of the lower right corner canister. Note the discoloration around the grid voltage plug and the well-defined discoloration pattern on the tray wall.

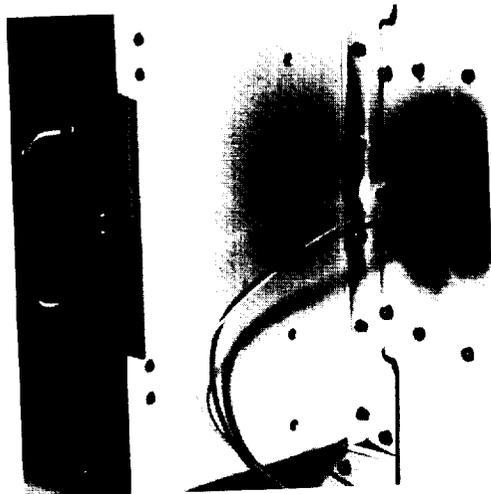
Figure 474
Photo No.: KSC-390C-1602.05
Dup. Neg. No.: L91-10796
LISAR No.: EL-1994-00655
Photo Credit: KSC
Photo Date: 3/5/90
Location: KSC SAEF II
Subject: Postflight Detail of Grid Voltage Plug
Located to Right of Upper Left Canister of
Tray E12

Figure 474 (Postflight). This close-up photograph is of the grid voltage plug that was located to the right of the upper left canister. Note the discolored area around the plug and the discoloration pattern on the canister wall.

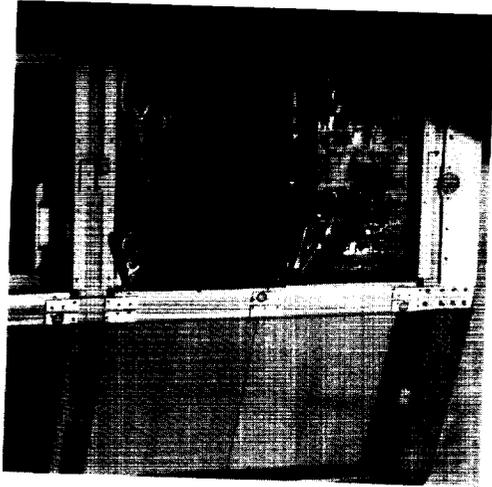
Figure 475 (In Flight). A portion of the greenish-gray tint on the two debris panels is a by-product of the chromic anodize coating process; however, a large part can be attributed to reflections of the blue sky. The vertical streaks in the panels are by-products of chromic anodizing that have been enhanced significantly by the blue reflection. Two darker blue horizontal discolorations are visible near the vertical center of each panel.

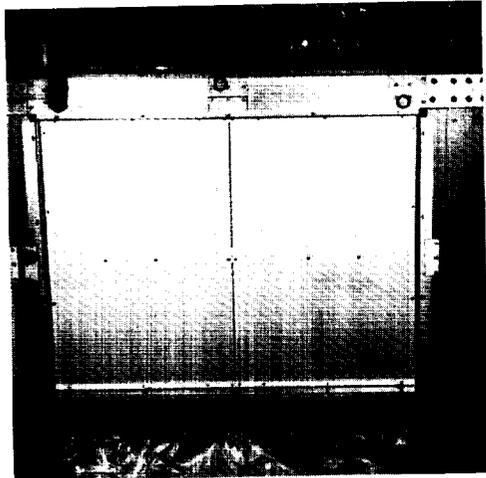
Figure 476
Photo No.: KSC-390C-1066.07
Dup. Neg. No.: L90-13476
LISAR No.: EL-1994-00186
Photo Credit: KSC
Photo Date: 2/8/90
Location: KSC SAEF II
Subject: Postflight Survey of Tray F1

Figure 476 (Postflight). The pink and greenish-gray tints on the two debris panels are by-products of the chromic anodize coating process and are not attributed to contamination or exposure to the space environment. The vertical streaks that were on the panels in the in-flight photograph are still visible, but they are much lighter because the reflection of the sky is not present. The same can be said for the two discolorations; they are still visible, but are much lighter. The light band along the sides and across the bottom of the panels is caused by light reflecting from the tray sidewalls.

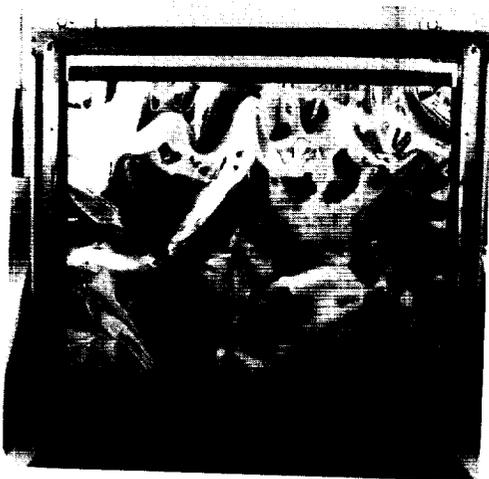
Figure 480
Photo No.: KSC-390C-1465.03
Dup. Neg. No.: L91-1553
LISAR No.: EL-1994-00193
Photo Credit: KSC
Photo Date: 2/23/90
Location: KSC SAEF II
Subject: Postflight Survey of Tray F2

Figure 480 (Postflight). The silvered Teflon thermal cover is without physical damage. The surroundings are reflected in the surface of the thermal cover. In general, the thermal cover appears specular except for an area in the lower center of the tray, which appears to be somewhat dull. A similar condition was noted on the thermal cover of tray A2 at the other end of the LDEF.
